**Order No.: DD+DIS166.02E**

**ADC Solo**

**Path Speed CR SP1001**

## **Replacement of a broken light barrier flag at the Cassette Opener**

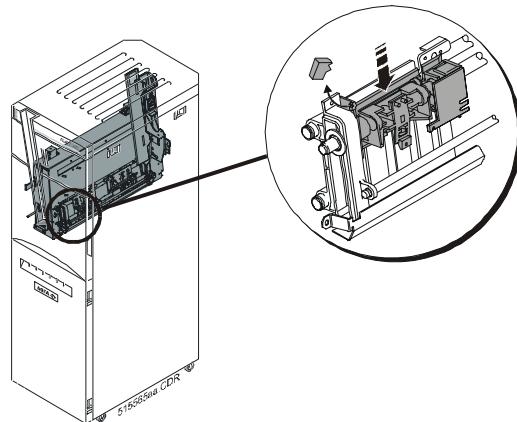
The light barrier flag (see figure beside) of the cassette opener may break when it touches the frame of the cassette opener.

The cassette opener (LHS) remains in the home position and is not moved to the middle position when the cassette holder is lowered manually.

Exchange the broken part.

Order number: **CM+9.5146.5911.0**

Spare part can be ordered separately. It is not necessary to order a complete cassette opener!
